POTENTIAL FAILURE MODE ANALYSIS
KOOTENAI DEVELOPMENT IMPOUNDMENT DAM

LINCOLN COUNTY, MONTANA

August 23, 2011

Billmayer & Hafferman, Inc.
Kalispell, MT

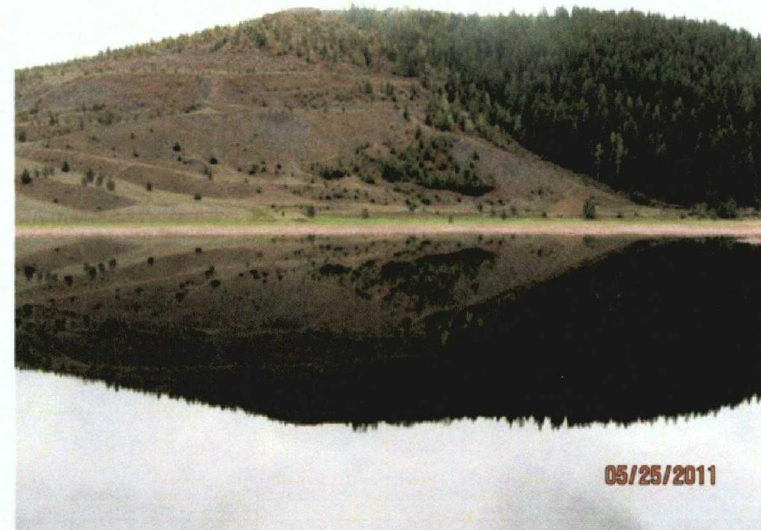
Steep Slope above Reservoir

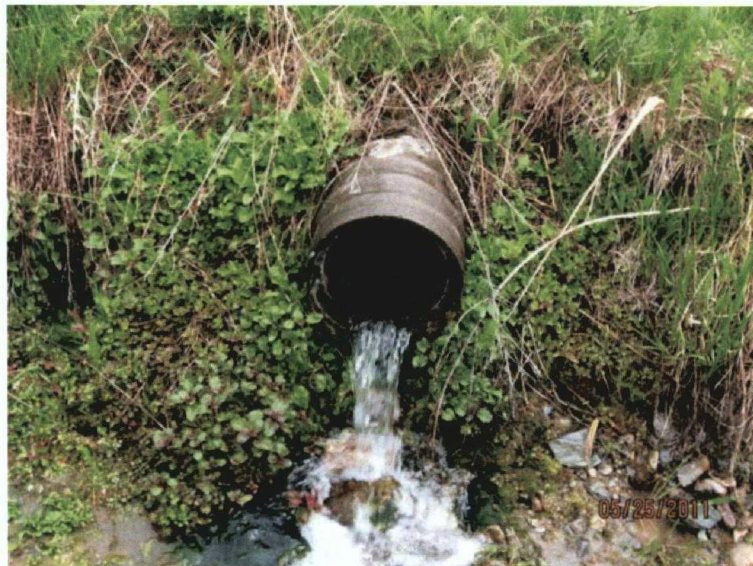
Seepage Near Drain 9

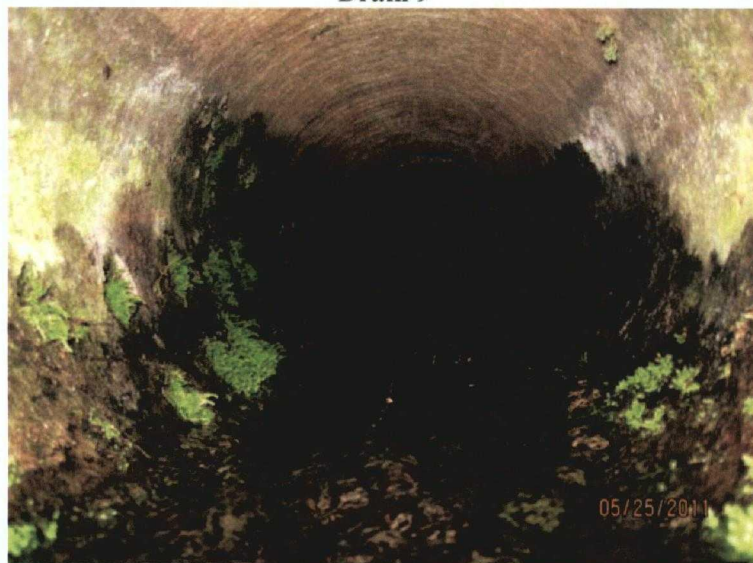
Seepage between Drain 9 and Drain 13

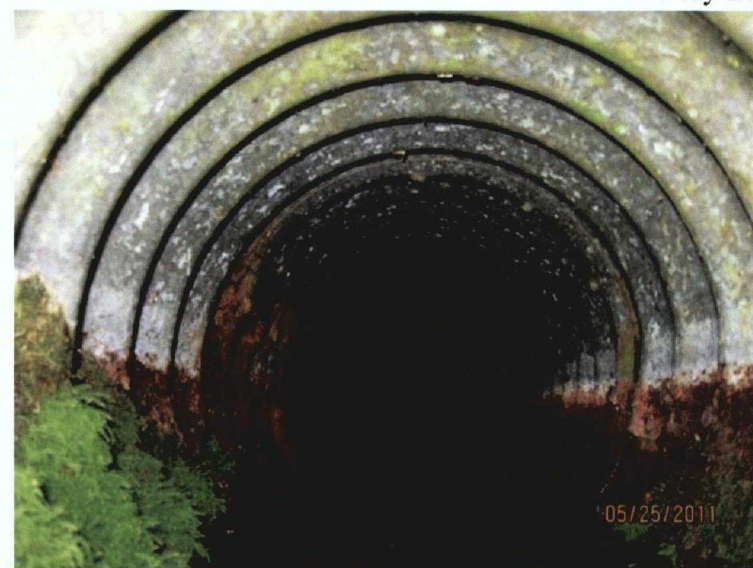
Seepage between Drain 13 and Drain 10

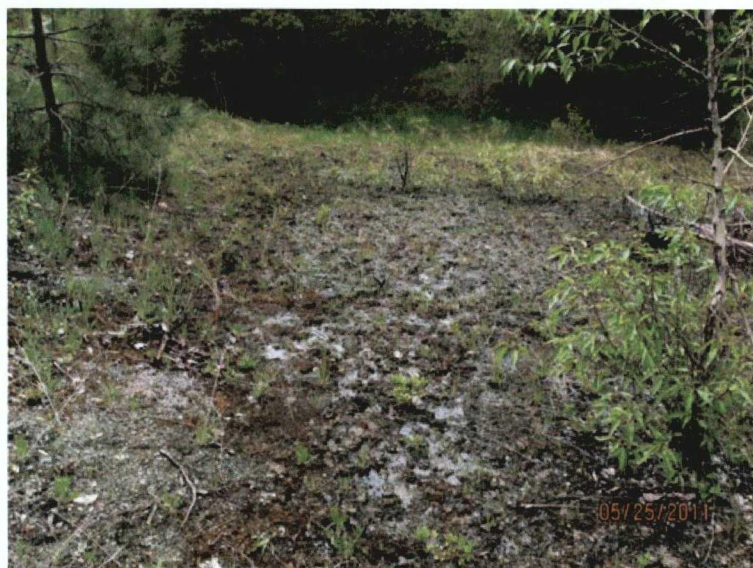
Seepage into Drain 12 above Weir

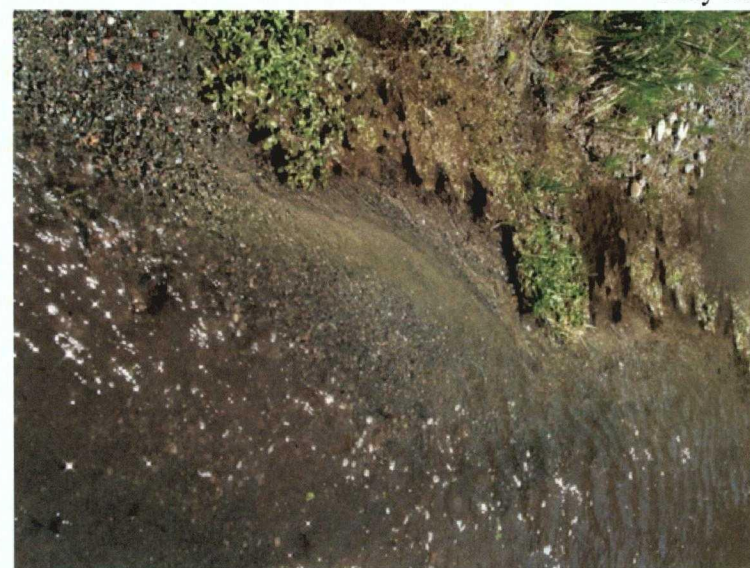
Saturated Area above Drain 12

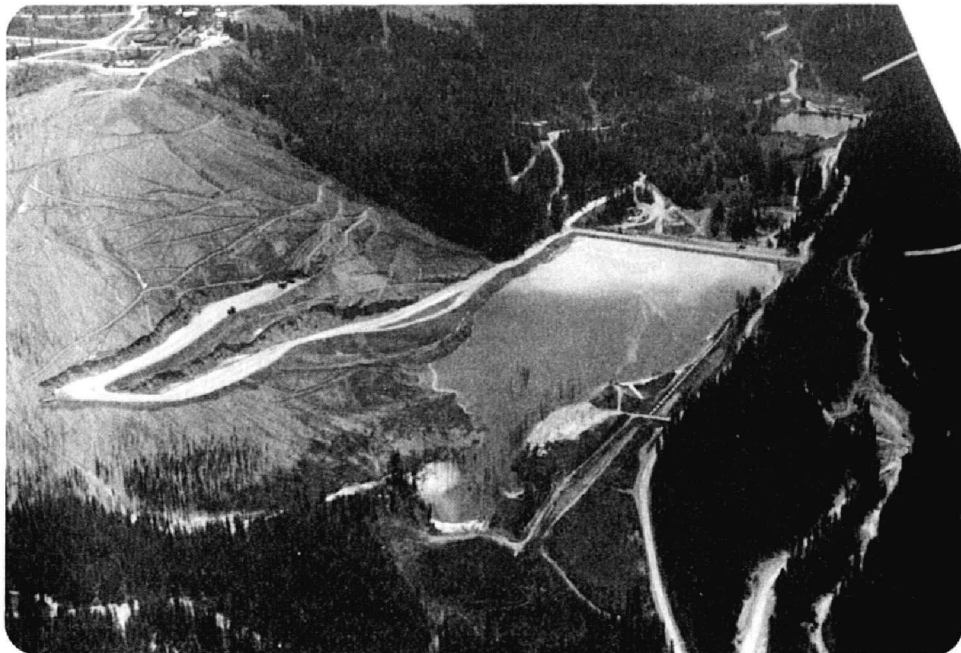
Photo 2 Aerial View of Zonolite Dam and Area Immediately Downstream (7-25-80)

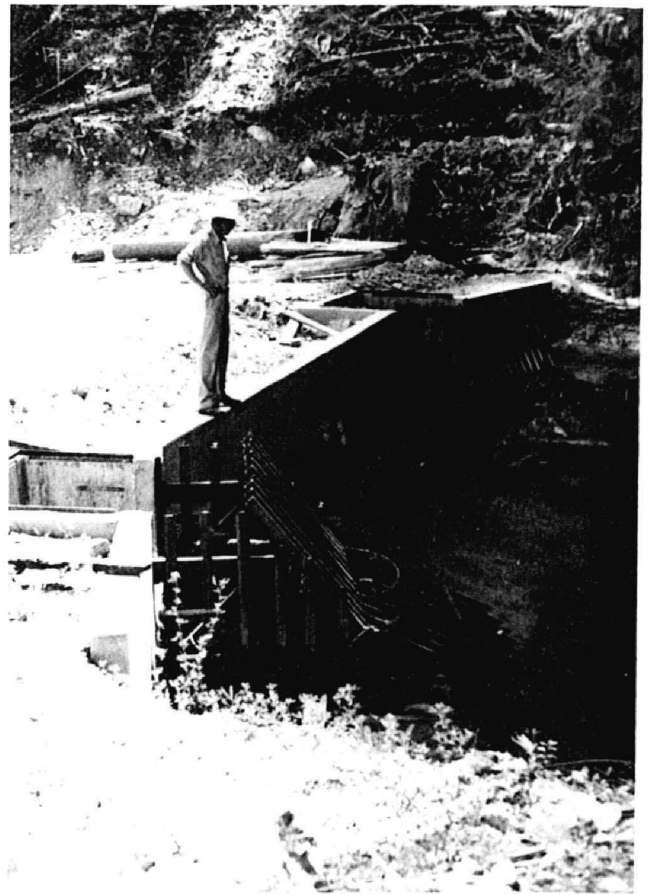
Photo 4
Rainy Creek Diversion Structure
Foreground: Entrance to Rainy Creek -
Background: Entrance to Diversion Pipeline
(8-13-81)

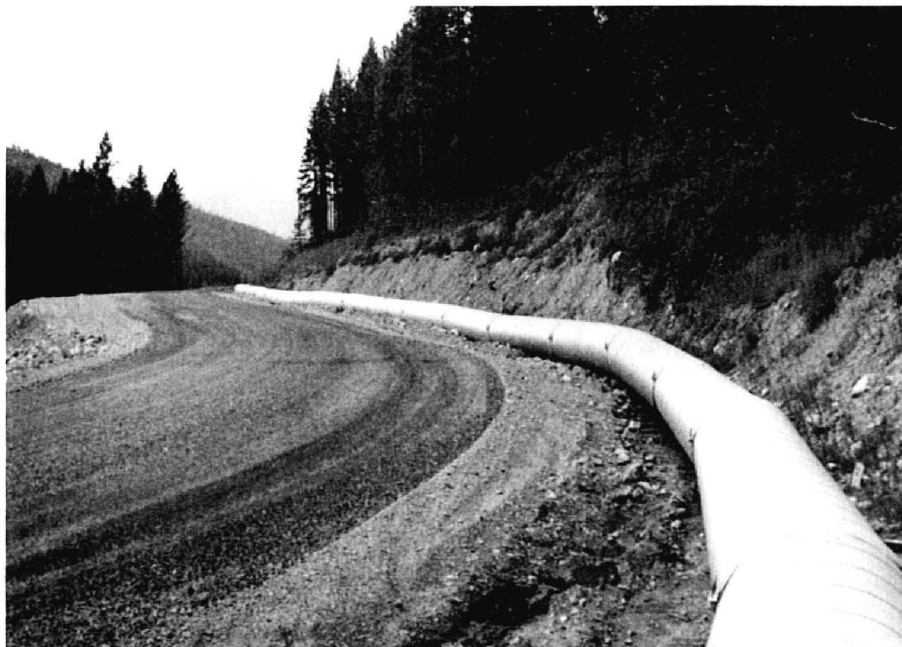
Photo 5 Rainy Creek Diversion Pipeline Along Rainy
Creek Road (7-81)

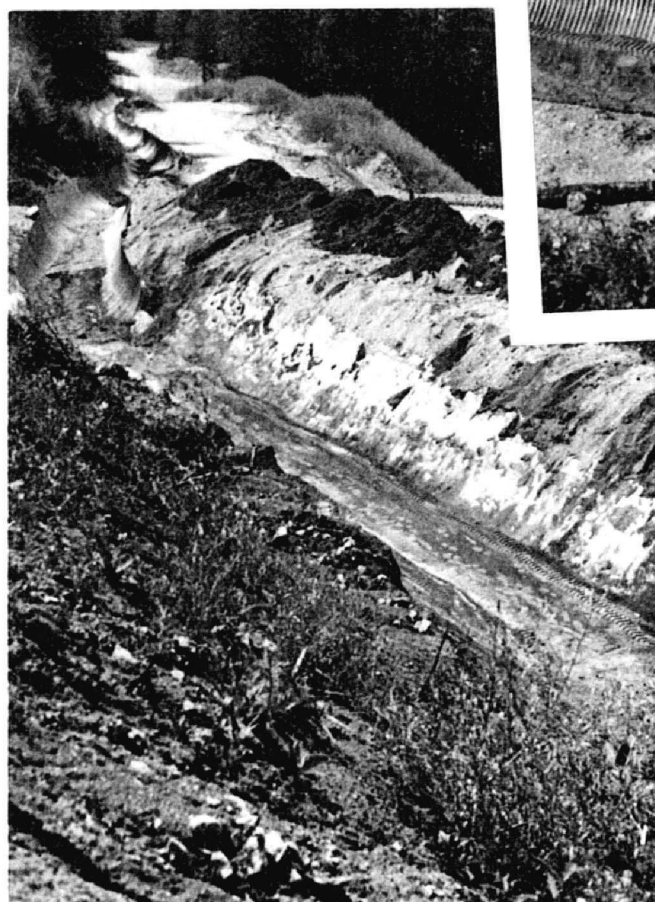
The spillway consists of an unlined trapezoidal shaped approach channel with a concrete transitional inlet structure which leads to half-sections of 8-foot diameter corrugated metal pipe (CMP) that comprise the spillway chute. Two pipes carrying mine tailings cross the unlined trapezoidal channel only slightly above the invert elevation (Photo 8). These pipes would trap floating debris during periods of spillway use and reduce its capacity. Bank sloughing and deposition of material in this unlined approach channel also represents serious capacity reductions and should be prevented. The entrance elevation of spillway is approximately 5 feet below the dam crest. The trapezoidal channel which extends through the east abutment abruptly transitions to the CMP chute (Photos 6 and 7). The CMP chute meanders along the haul road near the left abutment at an eight percent slope for approximately 500 feet and discharges into an unlined roadside ditch. Discharges enter the natural drainage downstream of the embankment toe. No stilling basin or energy dissipater is provided for at the terminus of the spillway chute (Photos 12 and 13). The CMP is anchored to concrete collars at three points along its length (Photo 10) and is also anchored to the concrete trapezoidal section near the crest. Pipe sections are overlapped and bolted to each other but are not sealed to prevent seepage which could produce piping of foundation materials and cause the chute to fail (Photo 9). This assemblage of the spillway raises doubts that the spillway chute will safely handle any high flows. Because of the spillway location, the ability of the half-round pipe to withstand hydraulic forces under all flow conditions, is an important consideration to the safety of the dam.

Photo 7 Spillway Chute and Approach Channel (8-13-81)

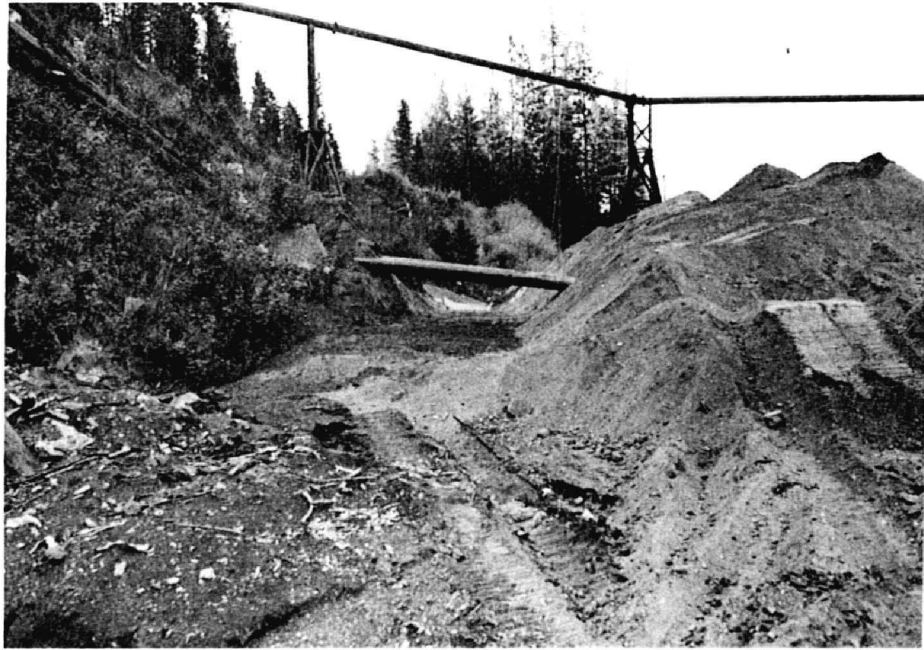
Photo 8 Spillway Approach Channel Looking Downstream (8-13-81)

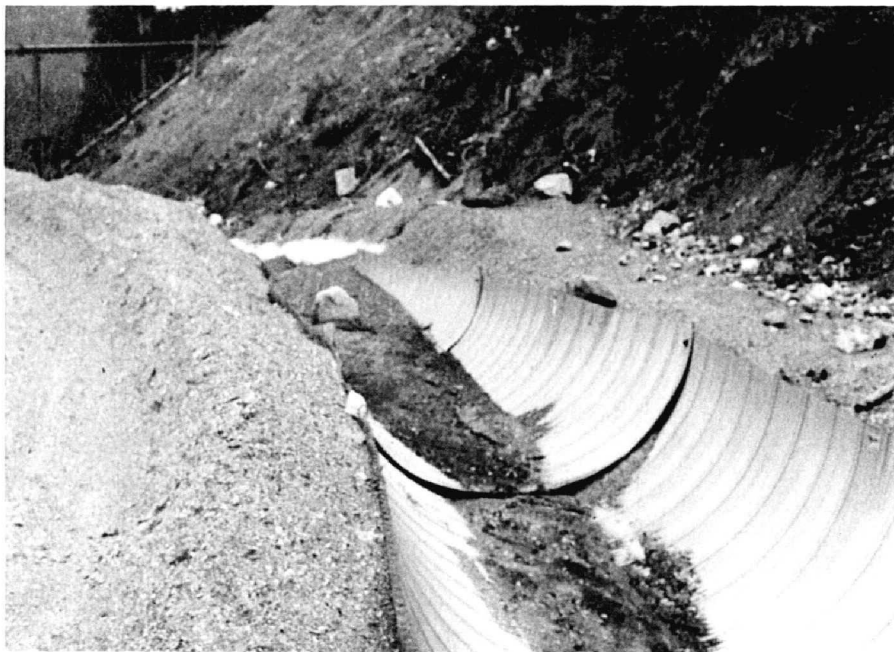
Photo 9 Spillway Chute Looking Upstream Near Crest.
Note Overlapping Joints (7-81)

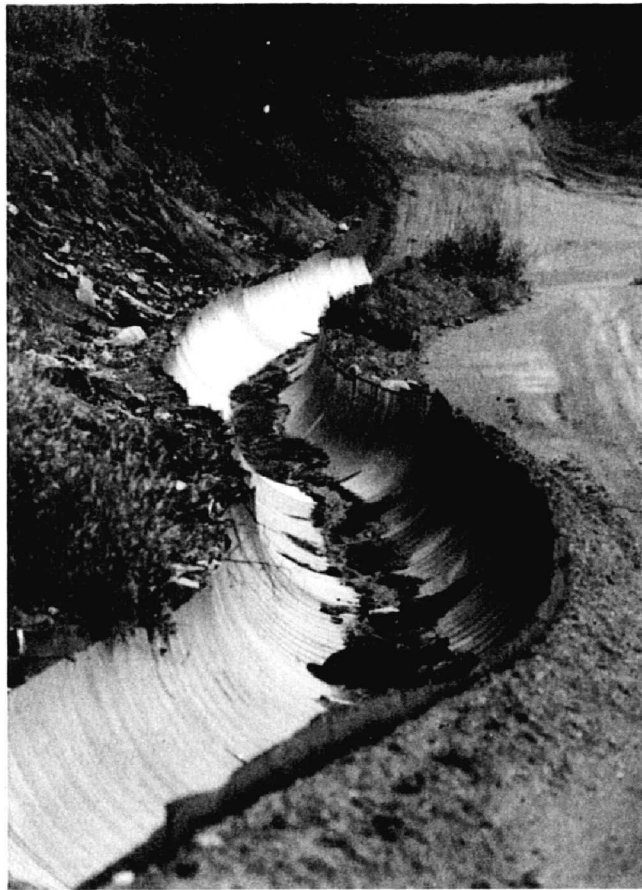
Photo 12 Bends in Spillway Chute Looking
Downstream (7-81)

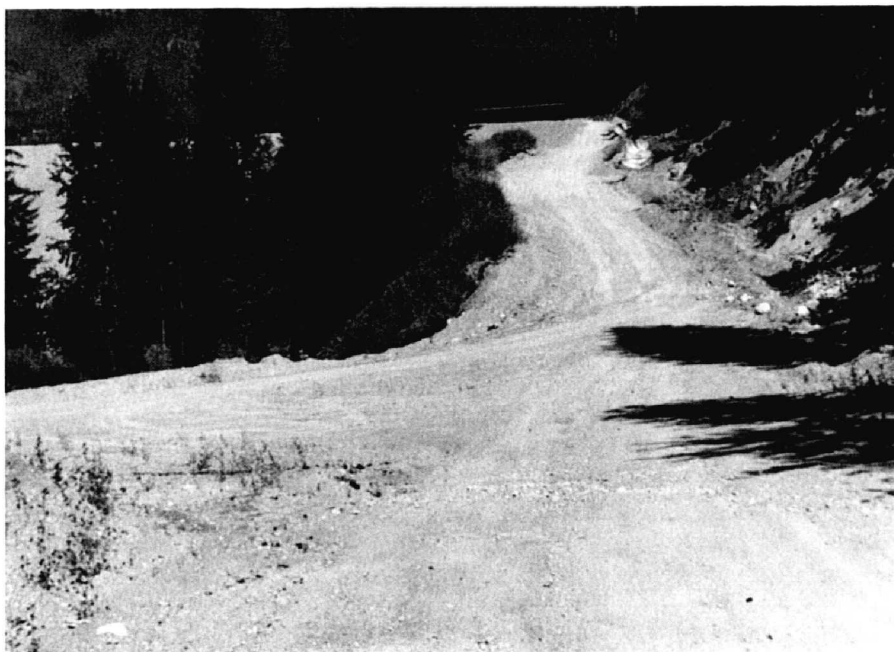
Photo 13 Downstream End of Spillway Chute Adjacent to
Haul Road (8-13-81)

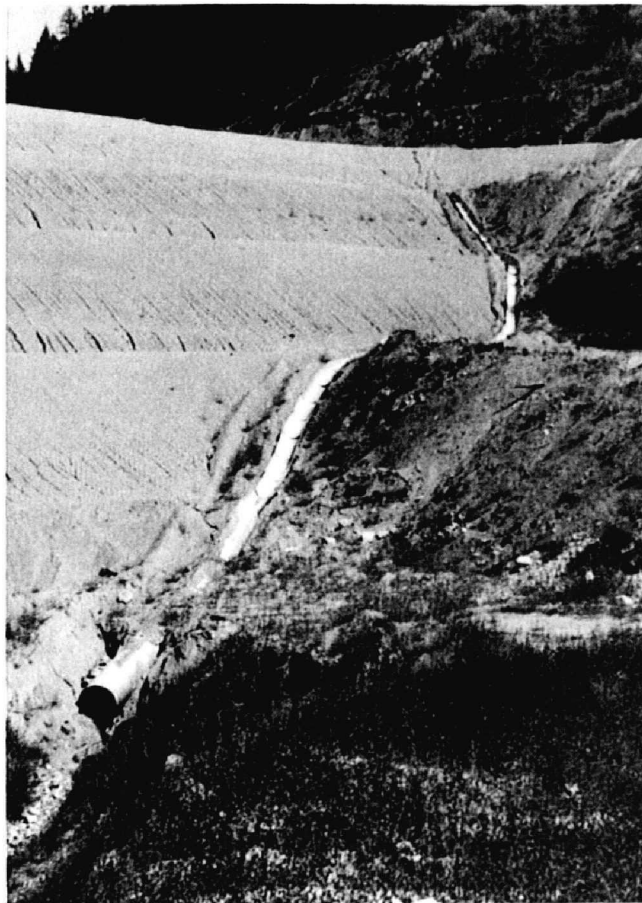
Photo 14 East Abutment Drain for Benches
on Downstream Face (8-13-81)

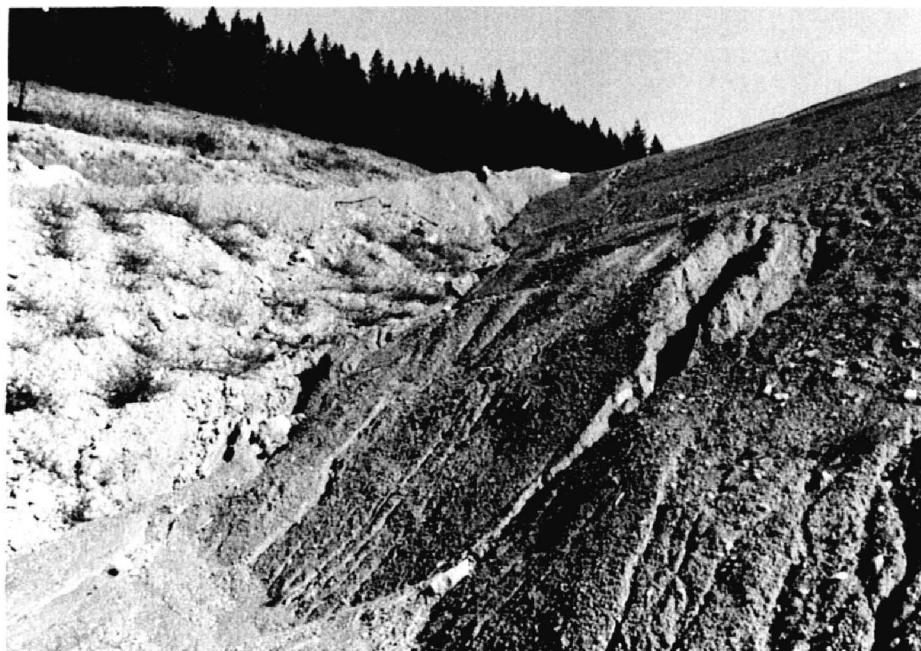
Photo 15 West Abutment Area. Note Rill Erosion (8-13-81)

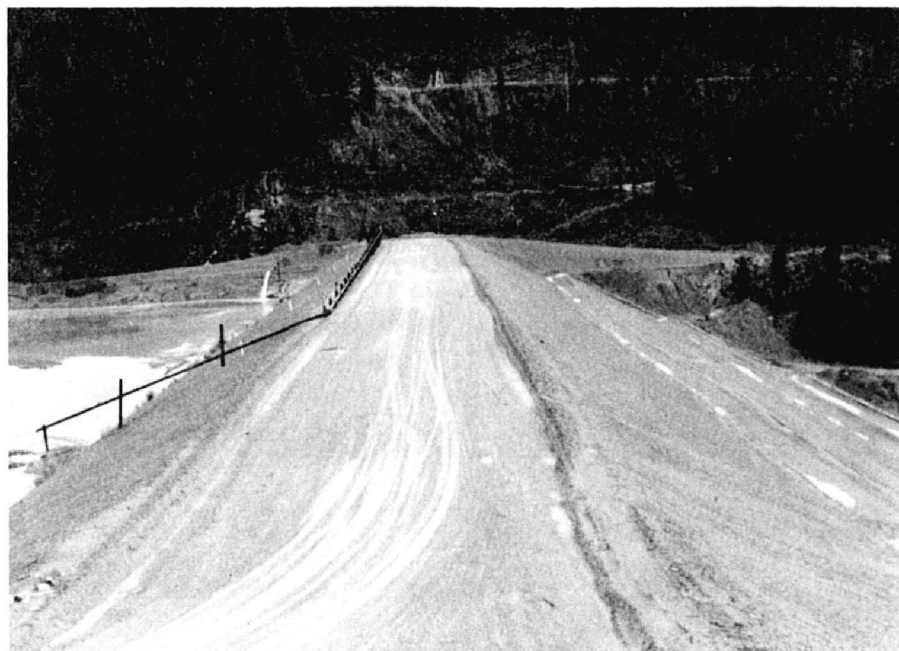
Photo 17 Upstream Face Looking Towards the West (8-13-81)

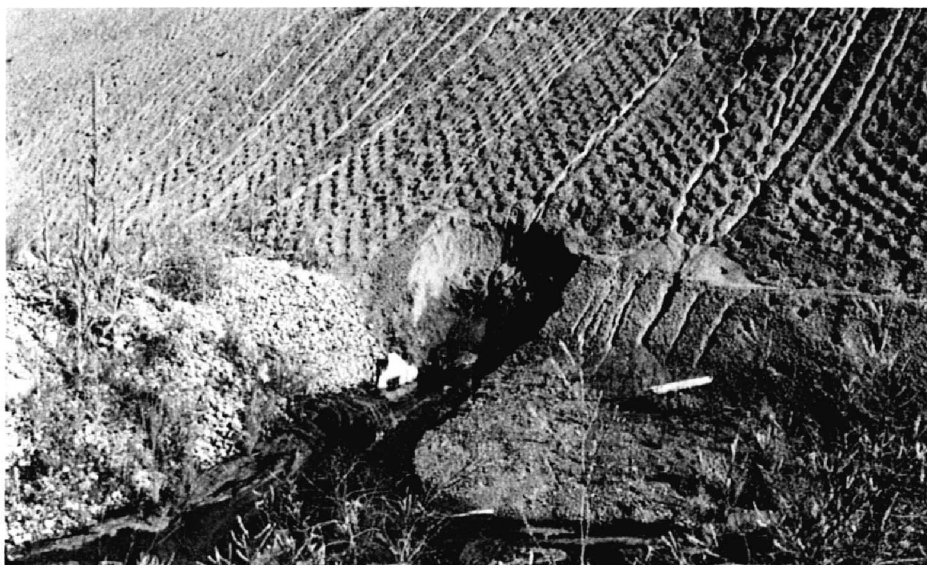
Photo 20 First Exposed Drain Closest to East (left) Abutment (8-13-81)
